**Flood Control Project Maintenance  
Levee Inspections**  
**LMA District Cover Sheet**  
**Spring 2018 Levee Inspection Results**

**Reclamation District No. 2094 Wathal**

**Levee Inspection Report By Mile - Spring 2018**

Waterway	Bank	Unit Miles	Inspection Start/End	Inspector
Unit No. 01 San Joaquin River	Right	2.78	03/13/2018 03/13/2018	Maksim Khashchuk

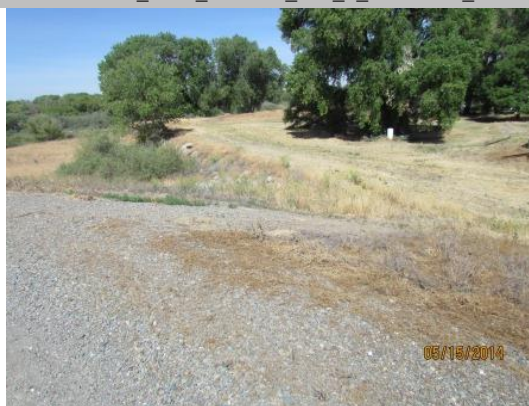
Photo 1 of 1 : SP\_2018\_RD2094\_320\_4\_20180305\_00001.jpg

LM Start	0.10	Rating **	M	Issue No.	4
LM End	0.10	Issue Type +	En	Location *	WS
Category	Earthen Levee			GPS Latitude/Longitude	
				Start	End
Item	Encroachments			37.771685 °	37.771685 °
				-121.300239 °	-121.300239 °
DWR ID	DWR_RD2094_01_s_2012_4				
Comment Code					
RA : Ramp					
Inspector Comment					
An access ramp has been built on the water side and extends into the channel. This could potentially alter the channel capacity. This item was also noted in the USACE comments.

Tire marks shown onto the ramp from levee. Raised area extends to the trees in the background in the center of the photo.

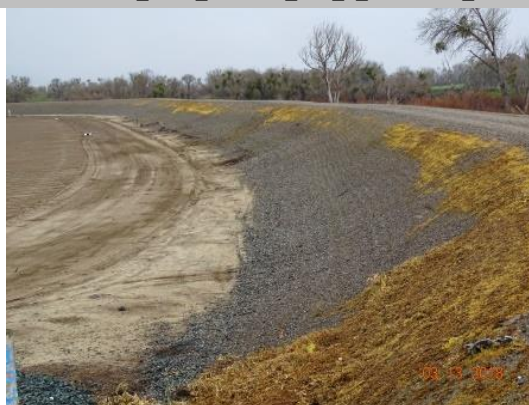
Photo 1 of 1 : SP\_2018\_RD2094\_320\_6\_20180314\_00015.jpg

LM Start	0.24	Rating **	A	Issue No.	6	
LM End	2.75	Issue Type +	Ma	Location *	LS	
Category	Earthen Levee			GPS Latitude/Longitude		
				Start		End
Item	Vegetation			37.769776 °		37.749979 °
				-121.301221 °		-121.289210 °
DWR ID	DWR_RD2094_01_s_2018_6					
Comment Code						
V1 : Control annual grass and weeds on the levee slopes and easements.						
Inspector Comment						
Acceptable vegetation control.

View of the acceptable vegetation control on the levee slope.

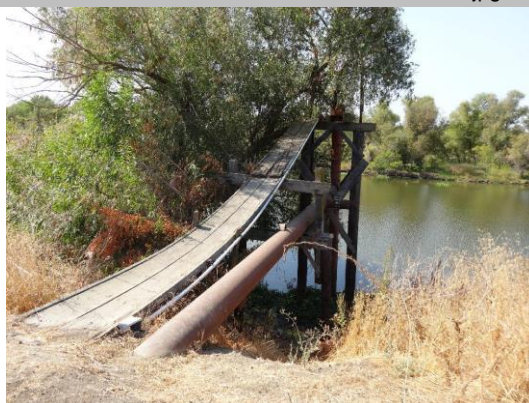
Photo 2 of 3 : UCIP\_SP\_2018\_21464\_36404.jpg

Comment Code						
Inspector Comment						
FS_ID:21464						
DS_ID:23086						
EP_NO: N/A						
Repair Type: Non-Urgent						
Crossing Status: Found						
UCIP Comments: - walkway in poor condition and needs repair.- electric conduit on waterside.						
FIELD_STRUCT_DESC: 14-inch concrete encased steel irrigation discharge pipe and galvanized iron (GI) electrical conduit through the levee, 10 feet below the crown. Two concrete cutoff walls. Pump mounted on a pile structure in the stream. Slide gate in a 54-inch corrugated metal pipe (CMP) riser on the waterside (WS) shoulder. Concrete distribution box and service pole at the landside (LS) toe. Installed by USACE in 1962. [Additional Reference(s): DWR Levee Log, 2005. USACE San Joaquin O&M Manual 3, December 1968, (HLM 0.66)].						
FS Date: 9/10/2013

WS view: pump on piling structure in the channel. Pipe (right- bottom) and conduit (bottom- left).

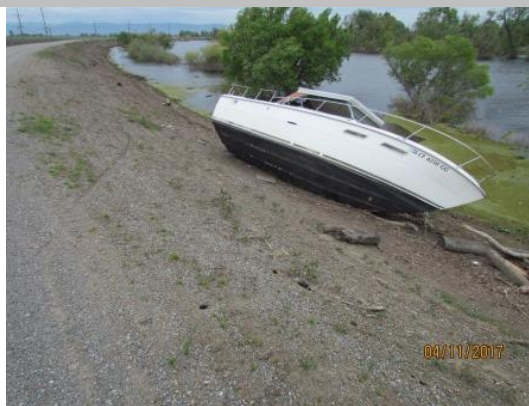
Photo 1 of 1 : SP\_2018\_RD2094\_320\_8\_20180305\_00002.jpg

LM Start	0.91	Rating **	M	Issue No.	8
LM End	0.91	Issue Type +	En	Location *	WS
Category	Earthen Levee			GPS Latitude/Longitude	
				Start	End
Item	Encroachments			37.764169 °	37.764169 °
				-121.293562 °	-121.293562 °
DWR ID	DWR_RD2094_01_s_2017_8				
Comment Code					
AV : Abandoned vehicles					
Inspector Comment					
Remove boat from the levee slope.

View of the boat on the levee slope.

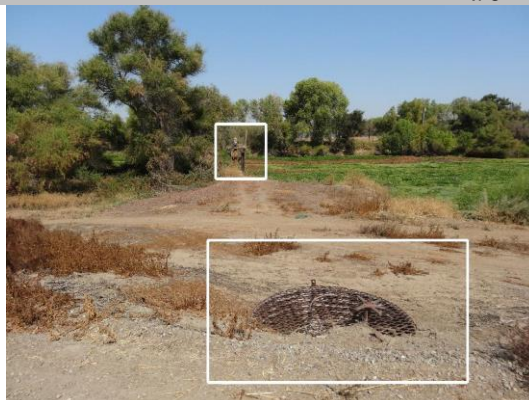
Photo 1 of 3 : UCIP\_SP\_2018\_21544\_36524.jpg

Comment Code					
Inspector Comment					
FS_ID:21544 DS_ID:23087 EP_NO: N/A Repair Type: Non-Urgent Crossing Status: Found UCIP Comments: - working as drainage system during field visit. Pump was not running.- electric conduit on WS- open pipe end in CMP riser. CMP needs cleaning. FIELD_STRUCT_DESC: 20-inch concrete encased steel irrigation discharge pipe through the levee, 10 feet below the crown. Two concrete cutoff walls. Pump mounted on a pile structure in the stream. Slide gate in a 54-inch corrugated metal pipe (CMP) riser on the waterside (WS) shoulder. Concrete distribution box and service pole at the landside (LS) toe. [Additional Reference(s): DWR Levee Log, 2005. USACE San Joaquin O&M Manual 3, December 1968, (HLM 1.27)]. FS Date: 9/10/2013

WS view: overview of pump (top) and CMP riser (bottom)

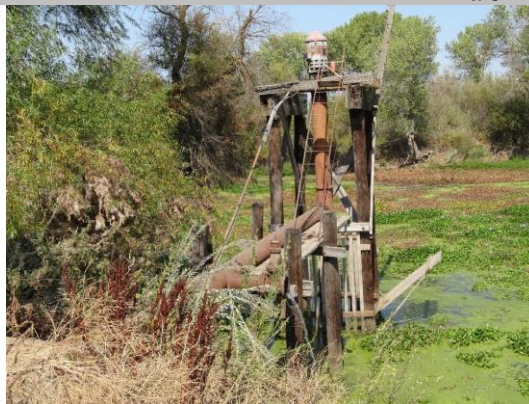
Photo 2 of 3 : UCIP\_SP\_2018\_21544\_36523.jpg

WS view: pipe and pump on piling structure in the channel. Walkway in poor condition.

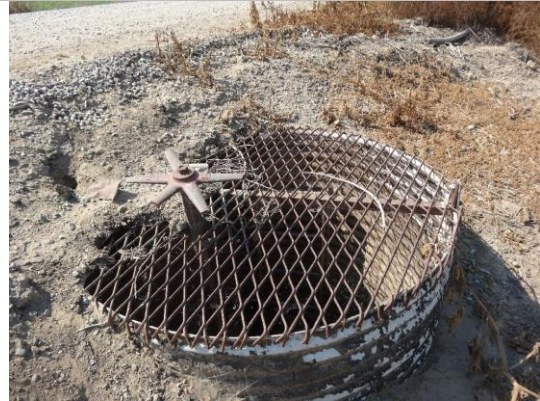
Photo 3 of 3 : UCIP\_SP\_2018\_21544\_36522.jpg

Comment Code						
Inspector Comment						
FS_ID:21544 DS_ID:23087 EP_NO: N/A Repair Type: Non-Urgent Crossing Status: Found UCIP Comments: - working as drainage system during field visit. Pump concrete cutoff walls. Pump mounted on a pile structure in the stream. riser. CMP needs cleaning. FIELD_STRUCT_DESC: 20-inch concrete encased steel irrigation discharge pipe through the levee, 10 feet below the crown. Two concrete cutoff walls. Pump mounted on a pile structure in the stream. Slide gate in a 54-inch corrugated metal pipe (CMP) riser on the waterside (WS) shoulder. Concrete distribution box and service pole at the landside (LS) toe. [Additional Reference(s): DWR Levee Log, 2005. USACE San Joaquin O&M Manual 3, December 1968, (HLM 1.27)]. FS Date: 9/10/2013

WS view: damaged gate valve handle in CMP riser on levee shoulder.

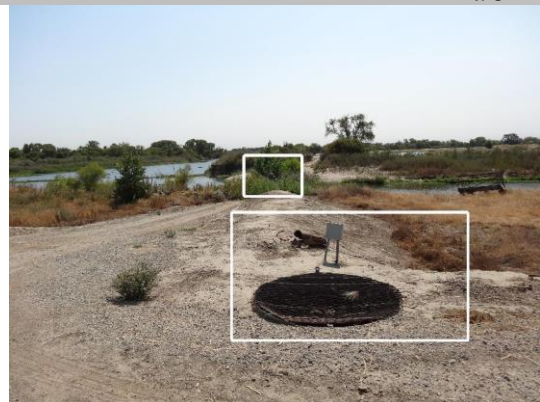
Photo 1 of 3 : UCIP\_SP\_2018\_41726\_36502.jpg

Comment Code					
Inspector Comment					
FS_ID:41726 DS_ID:23088 EP_NO: N/A Repair Type: Non-Urgent Crossing Status: Found UCIP Comments: - dense vegetation on WS.- working during field survey.- slide gate not found on WS. FIELD_STRUCT_DESC: 20-inch concrete encased steel irrigation discharge pipe through the levee, 6 feet below the crown. Two concrete cutoff walls. Slant pump mounted on a frame structure on the stream bank. Slide gate in a 54-inch corrugated metal pipe (CMP) riser on the waterside (WS) shoulder. Concrete distribution box and service pole at the landside (LS) toe. [Additional Reference(s): DWR Levee Log, 2005. USACE San Joaquin O&M Manual 3, December 1968, (HLM 2.30)]. FS Date: 9/10/2013

WS view: slant pump (top) on stream bank and CMP riser on levee shoulder.

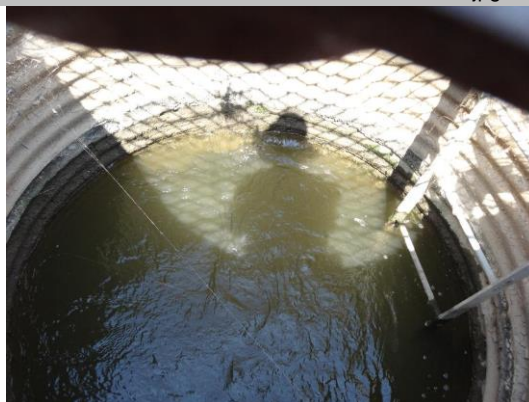
Photo 3 of 3 : UCIP\_SP\_2018\_41726\_36500.jpg

Comment Code						
Inspector Comment						
FS_ID:41726 DS_ID:23088 EP_NO: N/A Repair Type: Non-Urgent Crossing Status: Found UCIP Comments: - dense vegetation on WS.- working during field survey.- slide gate not found on WS. FIELD_STRUCT_DESC: 20-inch concrete encased steel irrigation discharge pipe through the levee, 6 feet below the crown. Two concrete cutoff walls. Slant pump mounted on a frame structure on the stream bank. Slide gate in a 54-inch corrugated metal pipe (CMP) riser on the waterside (WS) shoulder. Concrete distribution box and service pole at the landside (LS) toe. [Additional Reference(s): DWR Levee Log, 2005. USACE San Joaquin O&M Manual 3, December 1968, (HLM 2.30)]. FS Date: 9/10/2013

WS view: inside view of CMP riser on levee shoulder. No slide gate found.

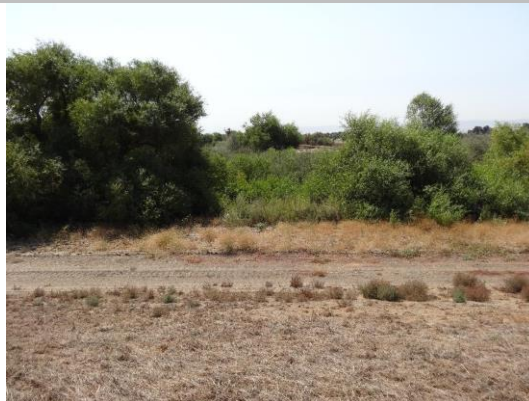
Photo 1 of 3 : UCIP\_SP\_2018\_21545\_36529.jpg

LM Start	2.45	Rating **	M	Issue No.	16
LM End	2.45	Issue Type +	En	Location *	
Category	Supplemental			GPS Latitude/Longitude	
				Start	End
Item	DWR UCIP Field Study			37.752308 °	37.752308 °
				-121.293191 °	-121.293191 °
DWR ID					
Comment Code					
Inspector Comment					
FS_ID:21545 DS_ID:23089 EP_NO: N/A Repair Type: Non-Urgent Crossing Status: Found UCIP Comments: - no pipes found on either side of the levee.- concrete distribution box on LS. Soil erosion around distrinution box. FIELD_STRUCT_DESC: Rectangular concrete distribution box on the landward toe FS Date: 9/10/2013

WS view: no pipe found on waterside.

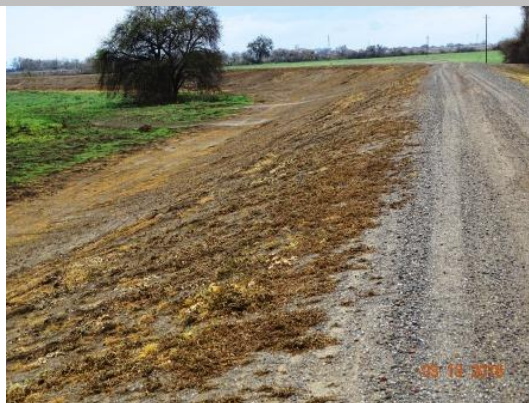
Photo 1 of 1 : SP\_2018\_RD2094\_321\_1\_20180314\_00002.jpg

LM Start	0.08	Rating **	A	Issue No.	1
LM End	0.42	Issue Type +	Ma	Location *	WS
Category	Earthen Levee			GPS Latitude/Longitude	
				Start	End
Item	Vegetation			37.759842 °	37.760621 °
				-121.300809 °	-121.306804 °
DWR ID	DWR_RD2094_02_s_2018_1				
Comment Code					
V1 : Control annual grass and weeds on the levee slopes and easements.					
Inspector Comment					
Acceptable vegetation control.

View of the acceptable vegetation control on the levee slope.
